Section 7 Results of Fieldwork

7.1 Results of Pedestrian Inspection

7.2 Test Excavation Results

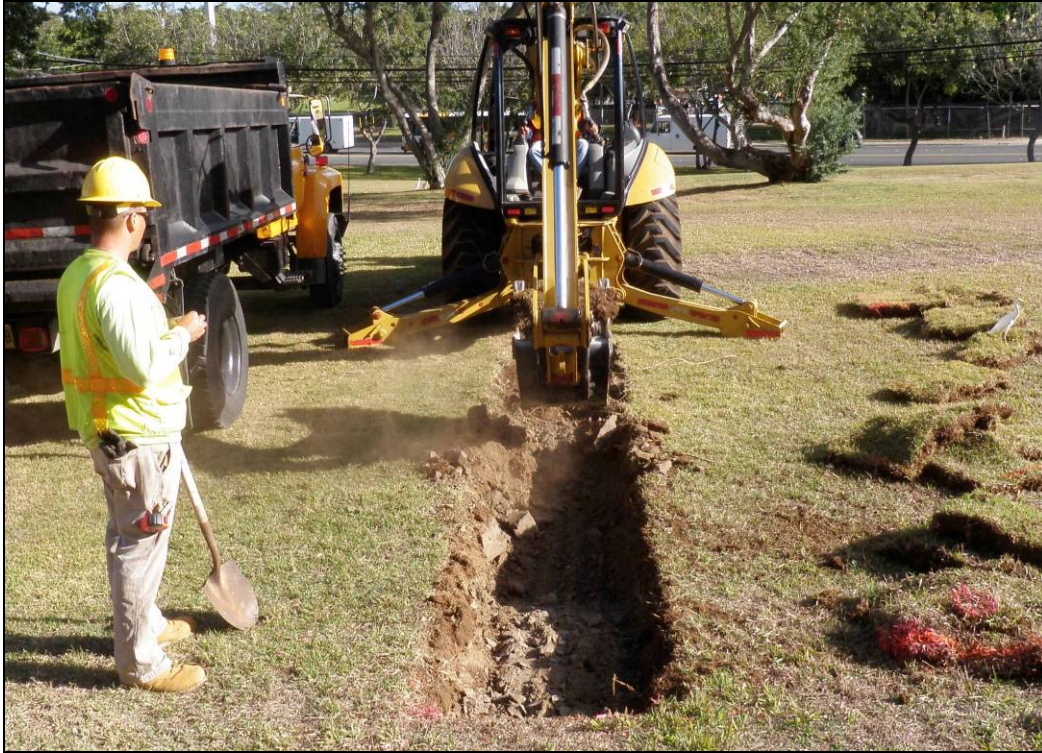
Figure 97. Photograph of Airport Section, T-010, general location Radford Drive in background, view to north

Summary: Excavation of T-010 encountered a thin topsoil fill layer (Stratum I) overlying extremely gravelly sand (Stratum II), and bedrock formed of decomposing tuff (Stratum III). Four highly oxidized nails, and a total of 2.0 g of marine shell were collected from Stratum II during excavation and subsequent screening of a 35-liter sediment sample. Stratum II is considered to be a possible remnant former land surface (A-horizon) that has been horizontally truncated and leveled. While cultural material was documented within Stratum II, the material was extremely sparse and not considered to be indicative of an activity area or cultural resource. No cultural resources were identified within T-010.

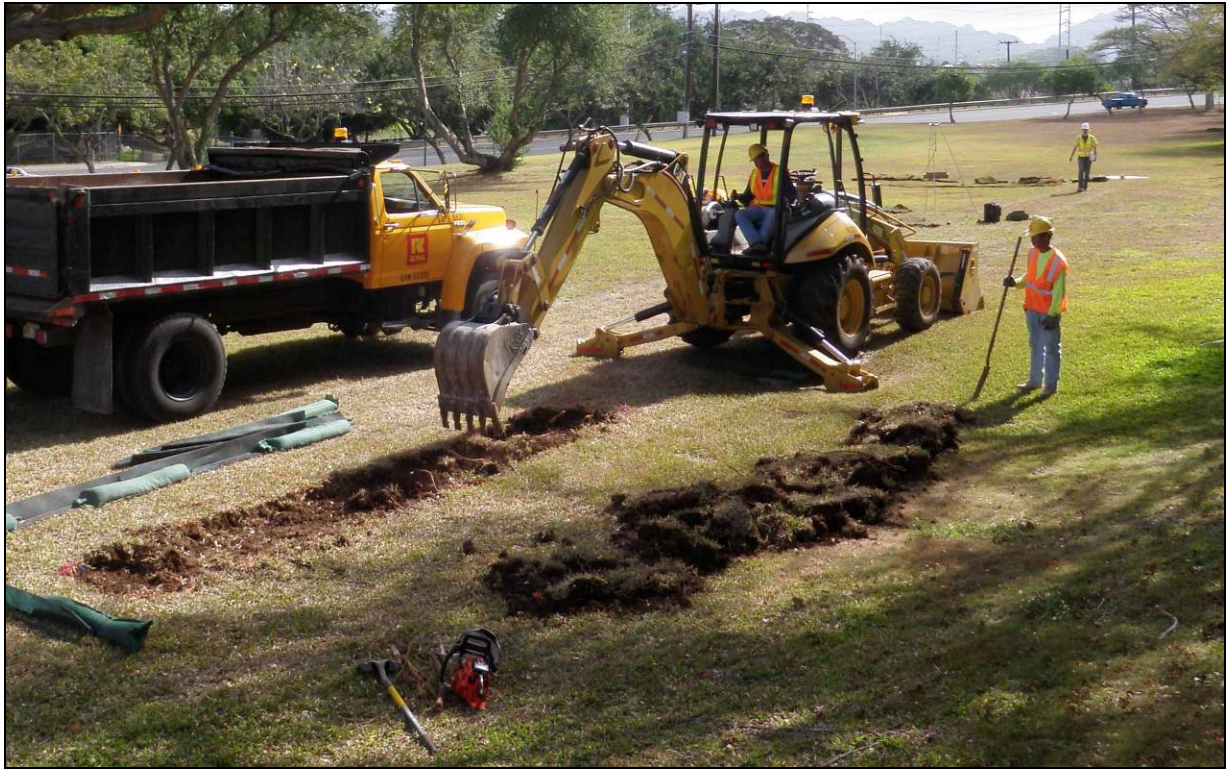
Figure 100. Photograph of Airport Section, T-011, general location, view to northeast, Test Excavation 8, Test Excavation 10 and Radford Drive in background

Summary: Excavation encountered one fill layer (Stratum I) over natural extremely gravelly silt (Stratum II) and volcanic tuff bedrock (Stratum III). The level lower boundary of Stratum I suggests the natural surface of Stratum II may have been graded prior to landscaping. No cultural resources were identified.

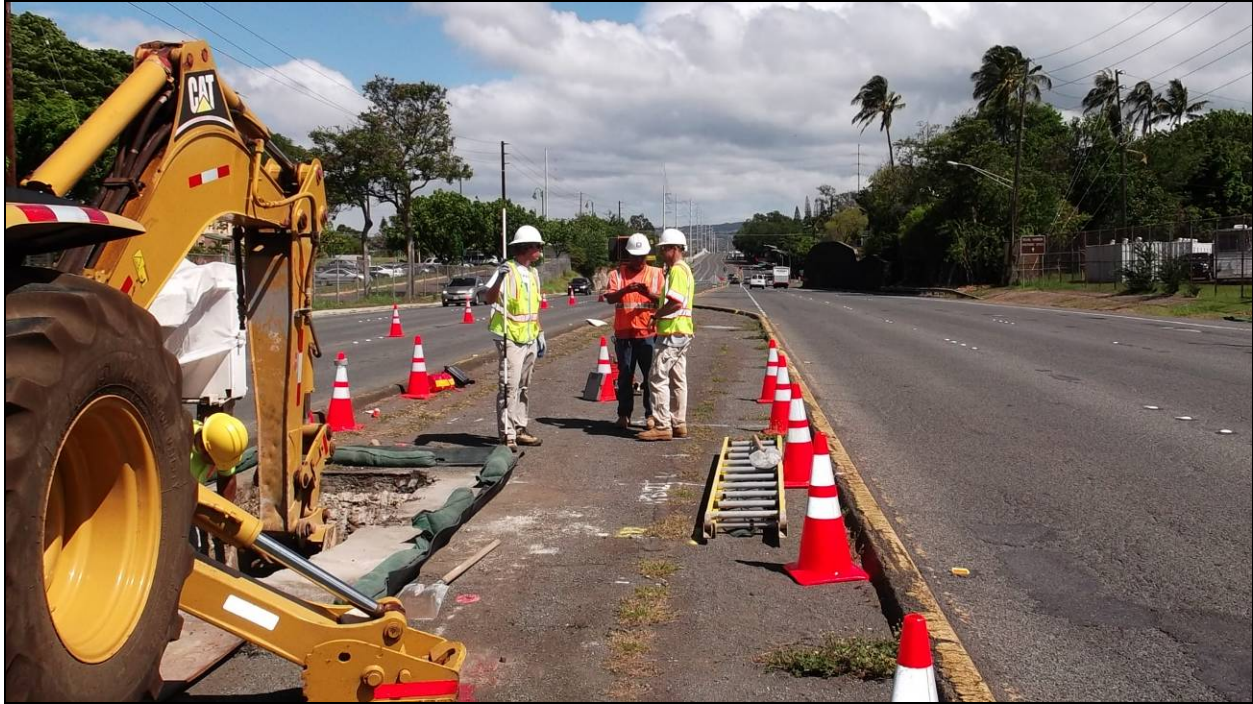
Figure 104. Photograph of Airport Section, T-012, general location, view to north

Setting: Test Excavation 12 (T-012) was located in the median between Kamehameha Highway and a highway on-ramp on a gentle slope (see Figure 103 and Figure 104). The excavation surface was level with the surrounding land.

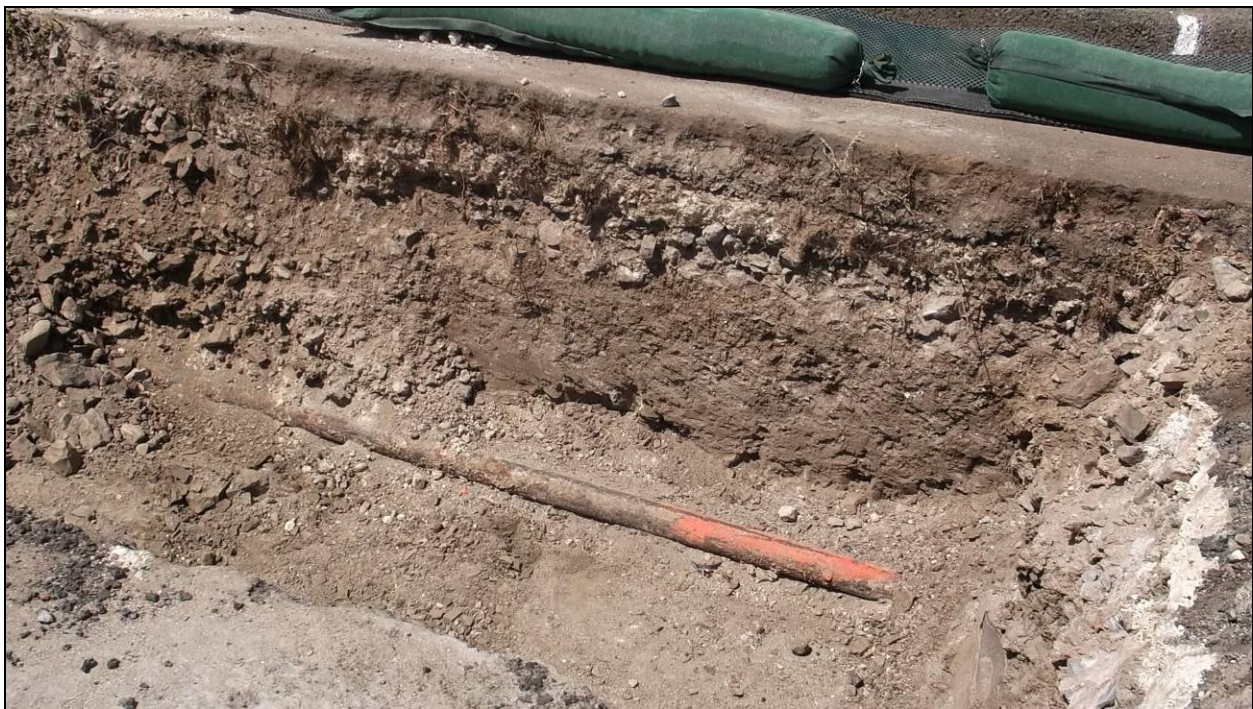
Figure 105. Photograph of Airport Section, T-012, general view of profile, view to west

Stratigraphic Summary: The stratigraphy, presented in Figure 105 and Figure 106, consisted of asphalt (Stratum Ia), crushed coral base course (Stratum Ib), and extremely gravelly silt loam (Stratum Ic) overlying decomposed volcanic tuff bedrock (Stratum II). The stratigraphy observed in T-012 is inconsistent with the USDA soil designation of Makalapa Clay (MdB). A surface exposure of volcanic tuff, likely deposited by Makalapa Crater, was observed in an adjacent road cut.

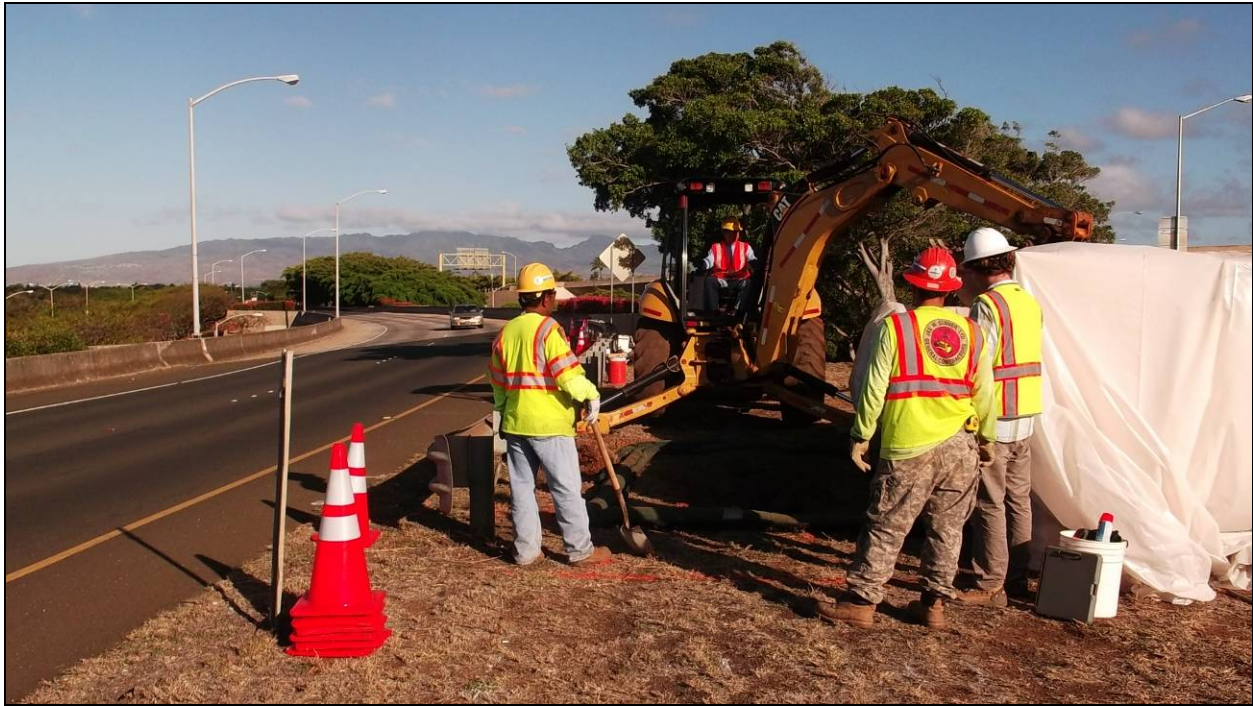
Figure 119. Photograph of Airport Section, T-016, general location, view to northwest

Summary: The stratigraphy within T-016 consisted entirely of fill (Stratum Ia-Ie) to the base of excavation. No natural sediments were encountered. The stratigraphy does not conform to the USDA soil designation of Makalapa clay (MdB). No cultural resources were identified.

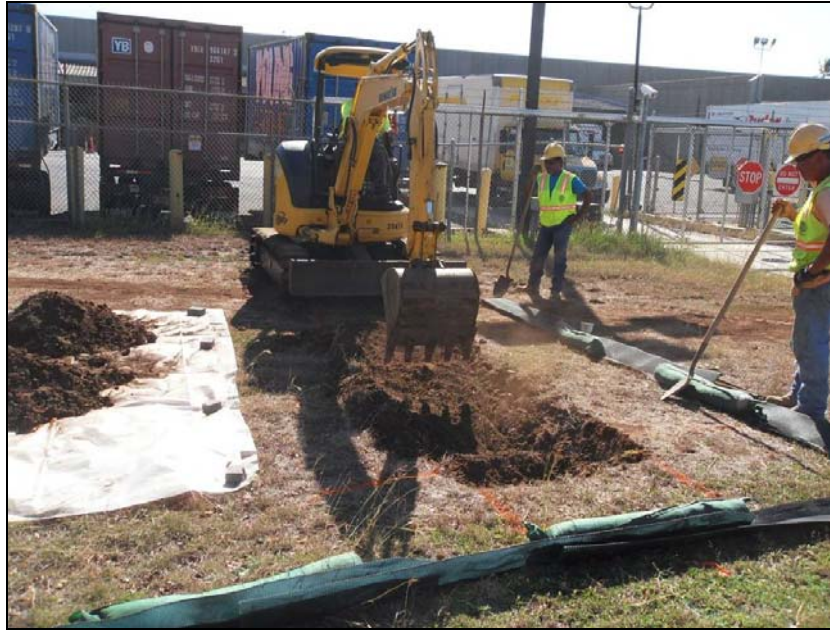
Figure 135. Photograph of Airport Section, T-020, general location, view to southeast

Setting: Test Excavation 20 (T-020) was located on a grassy median along Aolele Street between the sidewalk and the chain link fence of the airport Post Office (Figure 134 and Figure 135). The surface of the excavation was slightly higher than street level, but generally level with the surrounding land surface.

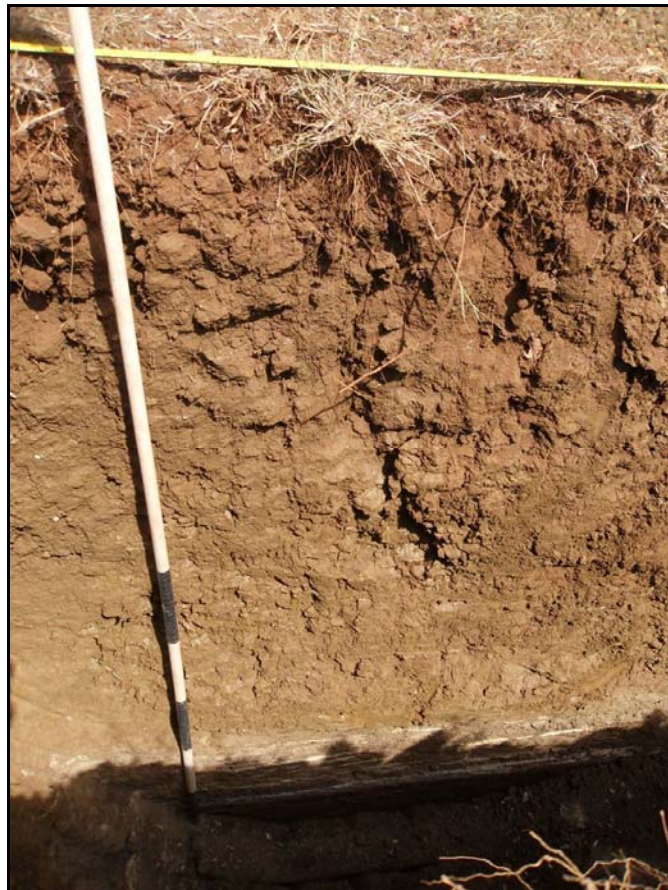
Figure 136. Photograph of Airport Section, T-020, general view of profile, view to west

Stratigraphic Summary: The stratigraphy, presented in Figure 136 and Figure 137, consisted of silty clay fill (Stratum Ia), sandy clay fill (Stratum Ib), and extremely gravelly loam fill (Stratum Ic) overlying natural silty clay (Stratum II) and volcanic tuff and ash (Stratum IIIa and IIIb).

Summary: Stratigraphy within T-020 consisted of fill (Stratum Ia-Ic) overlying possible Makalapa Clay (Stratum II) and volcanic tuff and ash deposits (Stratum IIIa and IIIb). Stratum II appears to conform with the USDA soil survey designation of Makalapa Clay (MdB). Bulk samples were collected from the natural strata (Strata II, IIIa, and IIIb) in order to further characterize the natural sediments and to screen for potential charcoal content. Wet-screening results were negligible. No cultural resources were identified.

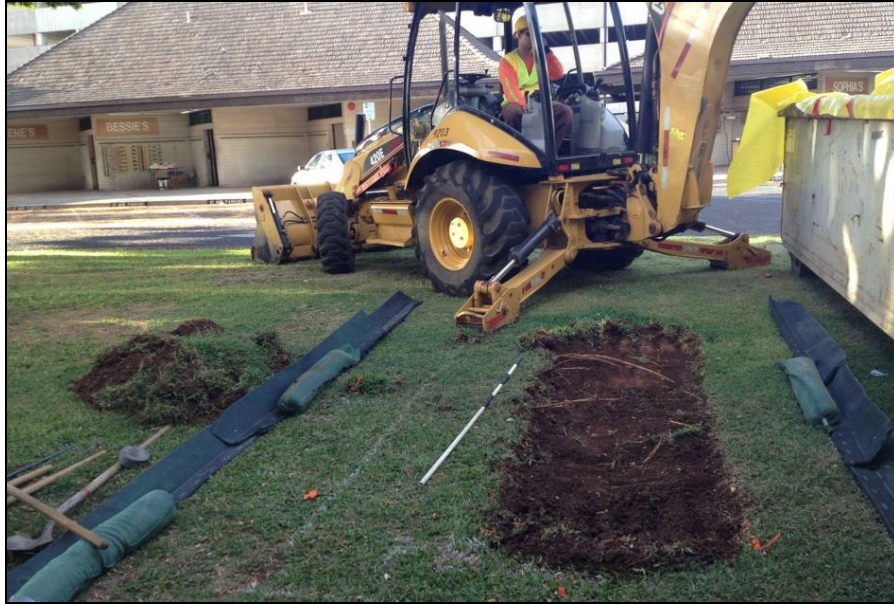
Figure 139. Photograph of Airport Section, T-021, general location, view to south

Setting: Test Excavation 21 (T-021) was located in the grassy area in front of the airport *lei* stands, near Ala Onaona Street and Rodgers Boulevard (see Figure 138 and Figure 139). The excavation surface is level with the land surface, though slightly elevated from the adjacent road surface.

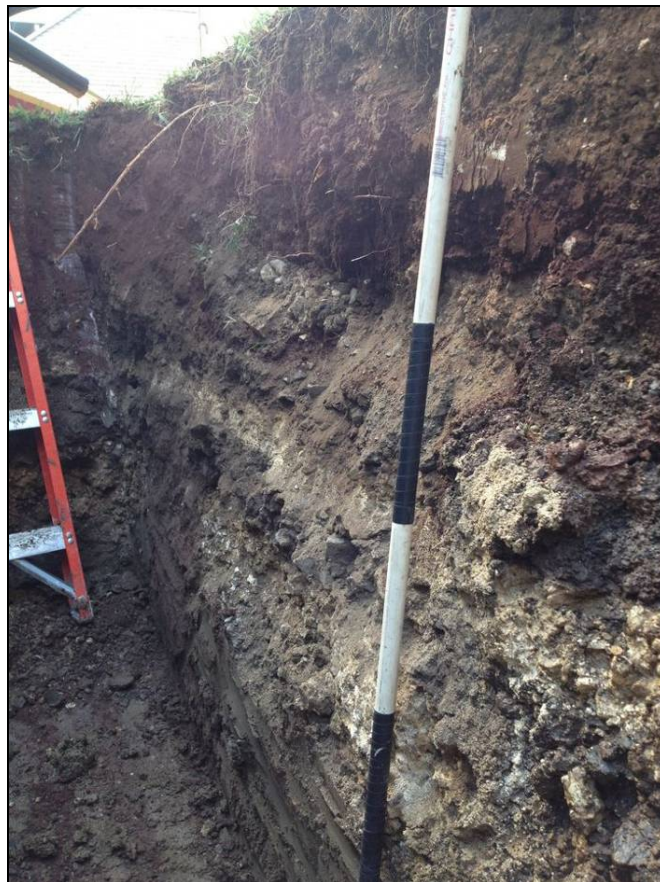
Figure 140. Photograph of Airport Section, T-021, general view of profile, view to southwest

Stratigraphic Summary: The stratigraphy, presented in Figure 140 and Figure 141, consisted of topsoil fill (Stratum Ia), topsoil subgrade (Stratum Ib), compacted coral pavement (Stratum IIa) and coral base course (Stratum IIb) overlying natural clay (Stratum III) and the coral shelf (Stratum IV). The overlying successive fill deposits are understood as associated with airport development. Stratum III appears to conform with the USDA soil survey designation of Keaau Stony Clay (KmaB).

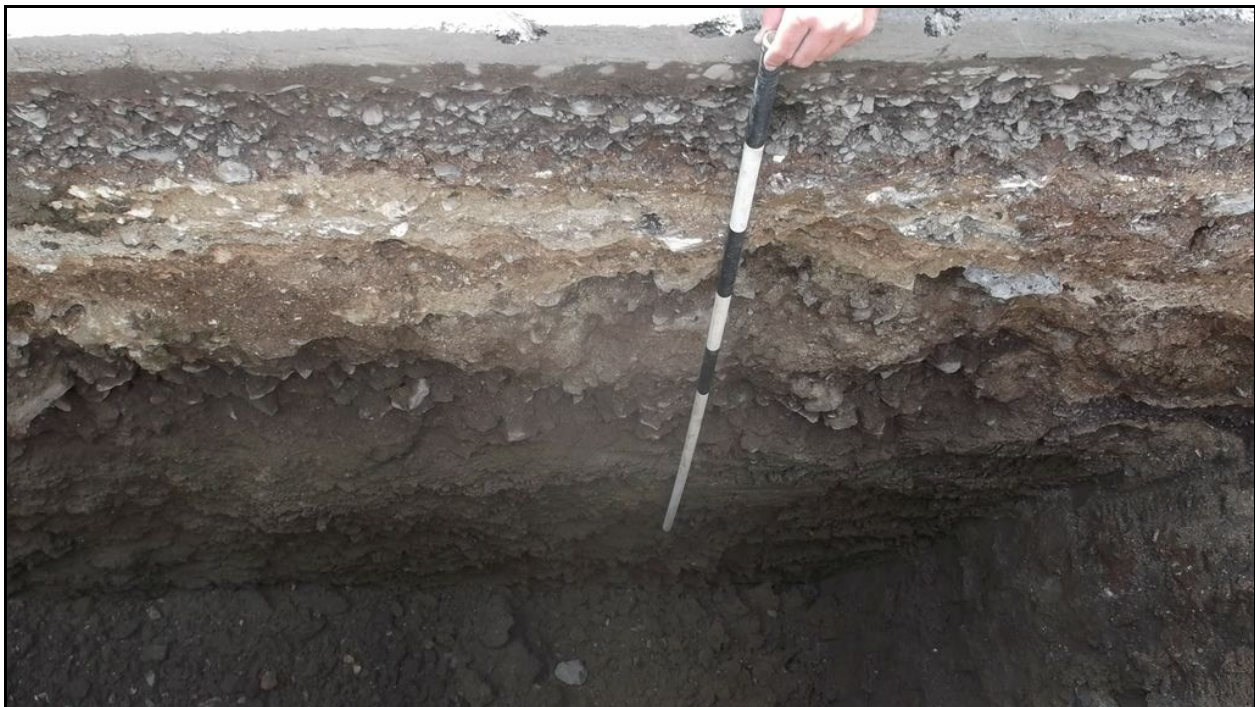
Figure 146. Photograph of Airport Section, T-022, general view of profile, view to southwest

Stratigraphic Summary: The stratigraphy, presented in Figure 146 and Figure 147, consisted of asphalt (Stratum Ia) and associated base course (Stratum Ib), crushed coral fill (Stratum Ic), and extremely cobbly sandy loam fill (Stratum Id) overlying natural silty clay loam (Stratum II). Cement blocks and block fragments were observed at the upper stratigraphic boundary of Stratum Id. The stratigraphy of T-022 conforms to the USDA soil survey designation of Fill Land (FL).

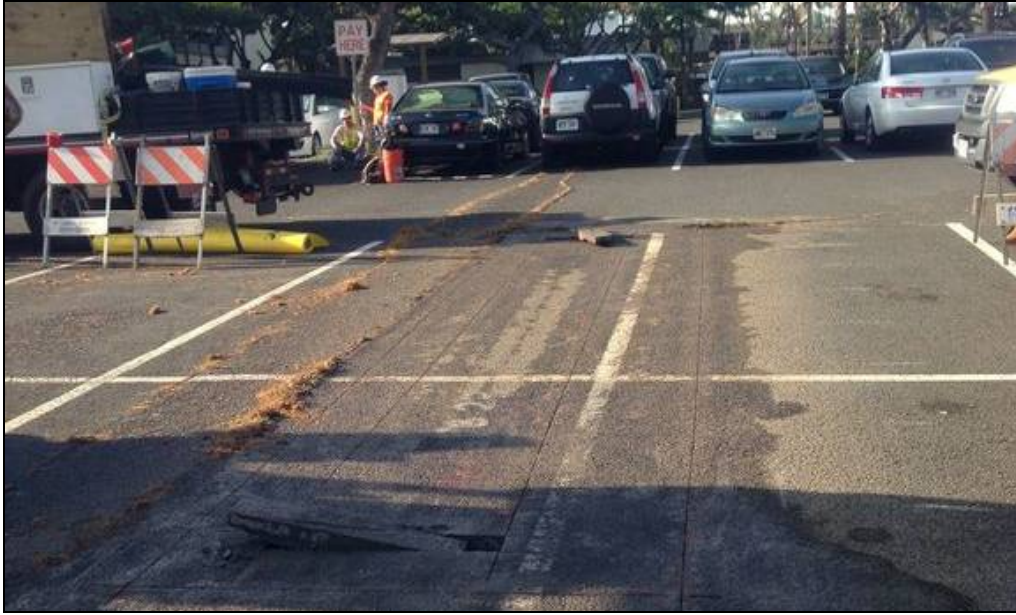
Figure 148. Photograph of Airport Section, T-023, general location, view to south

Setting: Test Excavation 23 (T-023) was located near the center of the parking lot at the *makai*/Diamond Head corner of Ala Onaona and Ala Auana Streets, parallel to Ala Auana Street (see Figure 142, Figure 143, Figure 144 and Figure 148). The excavation area is level with the surrounding parking lot, with a slight down slope towards Ala Onaona Street.

Summary: The stratigraphy of T-023 consisted of fill (Stratum Ia to If) overlying a buried concrete slab (Stratum II) at 115 cmbs. The stratigraphy of T-023 conforms to the USDA soil survey designation of Fill Land (FL). Excavation through and beneath the concrete slab was determined to be unsafe due to the potential for encased utility lines and sidewall instability. A 1943 map (Figure 19) indicates that during an expansive increase in military infrastructure development in 1942/1943, large buildings, understood as warehouses, were constructed in the immediate area of T-023 (with large buildings immediately to the east and west). A railroad spur line extended south from the OR&L rail line forming a loop in the immediate vicinity of T-023. This rail line suggests that large quantities of heavy material were stored in this immediate area. It seems likely that the buried concrete slab (Stratum II) within T-023 was a prepared, hard surface, possibly a receiving apron or dock, to facilitate the mass movement of supplies from the rail line to warehouses. The buried concrete slab, represented by Stratum II in T-023, has been designated as a component of SIHP# 50-80-13-7421 Feature 1 (see Section 7.4.3).

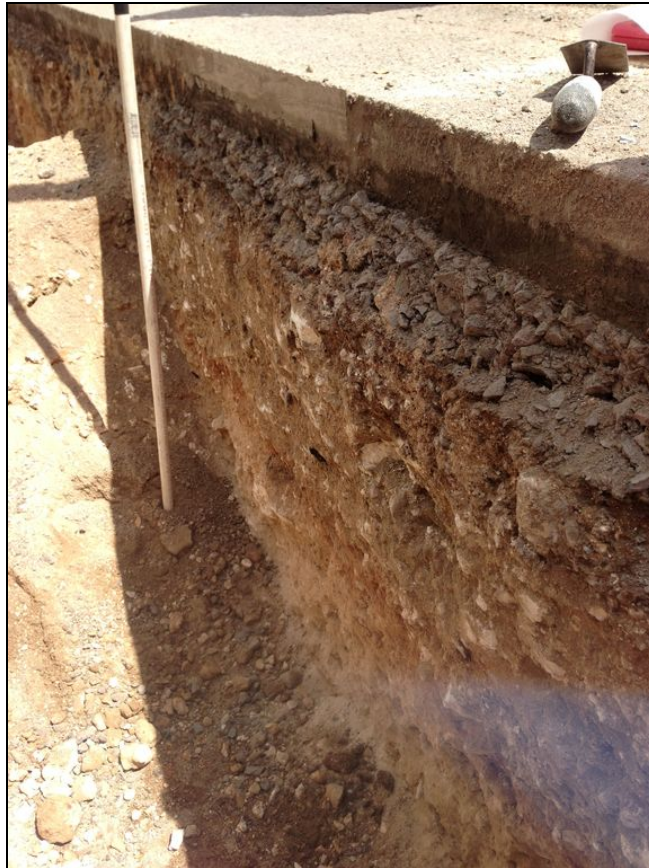
Figure 149. Photograph of Airport Section, T-023, general view of east profile, view to northeast

Stratigraphic Summary: The stratigraphy, presented in Figure 149 and Figure 150, consisted of asphalt (Stratum Ia) and associated base course (Stratum Ib), gravelly loam (Stratum Ic), very gravelly cobbly silty sand (Stratum Id), gravelly sand (Stratum Ie), and gravelly silty sand (Stratum If) overlying a buried concrete slab (Stratum II). The stratigraphy of T-023 conforms to the USDA soil survey designation of Fill Land (FL).

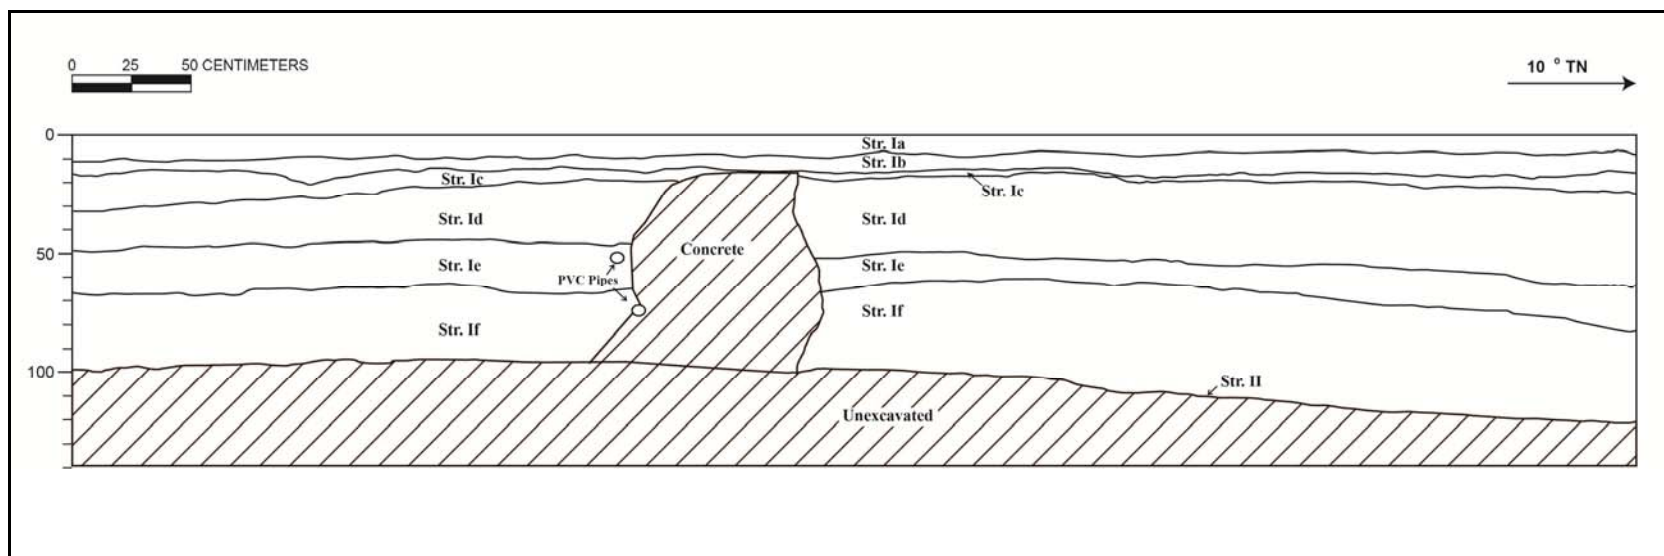
Stratum	Depth (cmbs)	Description
Ia	0-10	Asphalt
Ib	10-22	Fill; extremely gravelly sandy loam; 7.5 YR 3/1 (very dark gray); weak, medium, crumb structure; moist, friable consistency; non-plastic; terrigenous origin; abrupt, smooth lower boundary; gravel base coarse
Ic	20-27	Fill; gravelly loam; 5 YR 3/4 (dark reddish brown); weak, coarse, blocky structure; moist, friable consistency; slightly plastic; terrigenous origin; abrupt, smooth lower boundary
Id	20-46	Fill; very gravelly cobbly silty sand; 10 YR 6/4 (light yellowish brown); weak, fine, crumb structure; moist, friable consistency; non-plastic; mixed origin; abrupt, smooth lower boundary
Ie	45-81	Fill; gravelly sand; 7.5 YR 7/6 (reddish yellow); weak, fine, crumb structure; moist, friable consistency; non-plastic; mixed origin; abrupt, smooth lower boundary
If	65-115	Fill; very gravelly silty sand; 2.5 YR 7/4 (pale yellow); weak, very fine to fine, crumb structure; moist, friable consistency; non-plastic; mixed origin; abrupt, smooth lower boundary; contains PVC pipe and metal rod

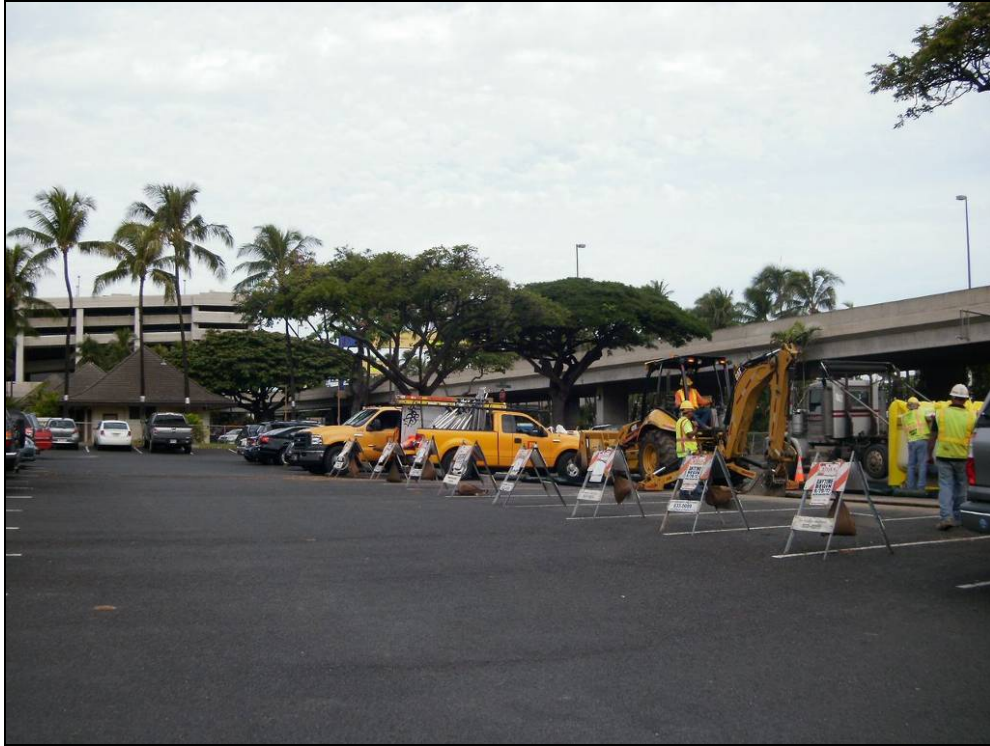
Figure 151. Photograph of Airport Section, T-024, general location, view to northwest

Setting: Test Excavation 24 (T-024) was located near the center of the parking lot at the *makai*/Diamond Head corner of Ala Onaona and Ala Auana Streets, parallel to Ala Onaona Street (see Figure 142, Figure 143, Figure 144 and Figure 151). The excavation area is level.

Summary: The stratigraphy of T-024 consisted of fill (Stratum Ia to Ic) overlying a buried concrete slab (Stratum II) at 108 cmbs. The stratigraphy of T-024 conforms to the USDA soil survey designation of Fill Land (FL). Excavation through and beneath the concrete slab was determined to be unsafe due to the potential for encased utility lines and sidewall instability. A 1943 map (Figure 19) indicates that during an expansive increase in military infrastructure development in 1942/1943, large buildings, understood as warehouses, were constructed in the immediate area of T-023 (with large buildings immediately to the east and west). A railroad spur line extended south from the OR&L rail line forming a loop in the immediate vicinity of T-024. This rail line suggests that large quantities of heavy material were stored in this immediate area. It seems likely that the buried concrete slab (Stratum II) within T-024 was a prepared, hard surface, possibly a receiving apron or dock, to facilitate the mass movement of supplies from the rail line to warehouses. The buried concrete slab, represented by Stratum II in T-024, has been designated as a component of SIHP# 50-80-13-7421 Feature 1 (see Section 7.4.3).

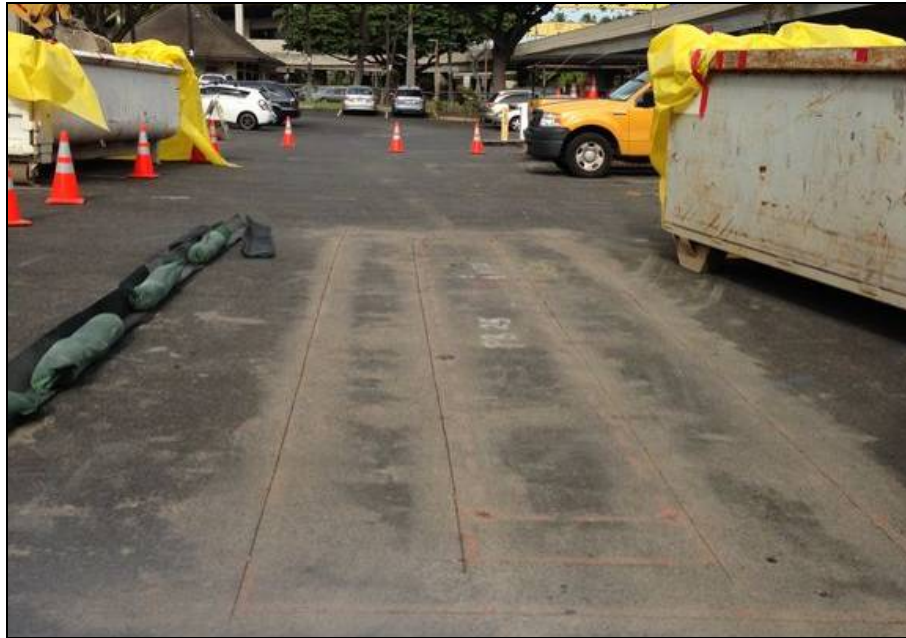
Figure 154. Photograph of Airport Section, T-025, general location, view to west

Setting: Test Excavation 25 (T-025) was located near the edge of the parking lot on the *makai*/Diamond Head corner of Ala Onaona and Ala Auana Streets, parallel with Ala Onaona Street (see Figure 142, Figure 143, Figure 144 and Figure 154). The excavation area is relatively flat in relation to the surrounding surface.

Summary: The stratigraphy of T-025 consisted of fill (Stratum Ia to Ic) overlying a buried concrete slab (Stratum II) at 90 cmbs. The stratigraphy of T-025 conforms to the USDA soil survey designation of Fill Land (FL). Excavation through and beneath the concrete slab was determined to be unsafe due to the potential for encased utility lines and sidewall instability. A 1943 map (Figure 19) indicates that during an expansive increase in military infrastructure development in 1942/1943, large buildings, understood as warehouses, were constructed in the immediate area of T-023 (with large buildings immediately to the east and west). A railroad spur line extended south from the OR&L rail line forming a loop in the immediate vicinity of T-025. This rail line suggests that large quantities of heavy material were stored in this immediate area. It seems likely that the buried concrete slab (Stratum II) within T-025 was a prepared, hard surface, possibly a receiving apron or dock, to facilitate the mass movement of supplies from the rail line to warehouses. The buried concrete slab, represented by Stratum II in T-025, has been designated as a component of SIHP# 50-80-13-7421 Feature 1 (see Section 7.4.3).

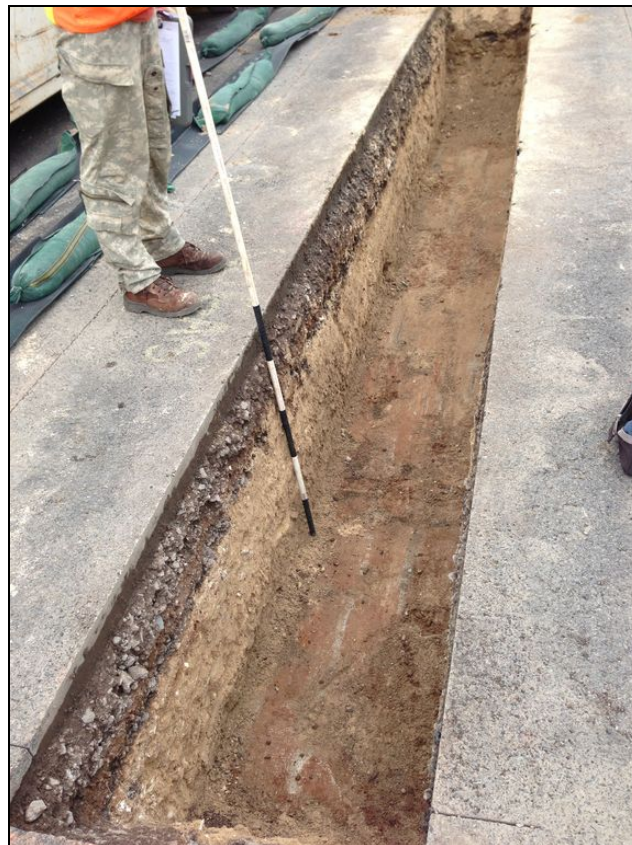
Figure 155. Photograph of Airport Section, T-025, general view of profile, view to northeast

Stratigraphic Summary: The stratigraphy, presented in Figure 155 and Figure 156, consisted of asphalt (Stratum Ia), associated base course (Stratum Ib), and crushed coral fill (Stratum Ic) overlying a buried concrete slab (Stratum II). The stratigraphy of T-023 conforms to the USDA soil survey designation of Fill Land (FL).

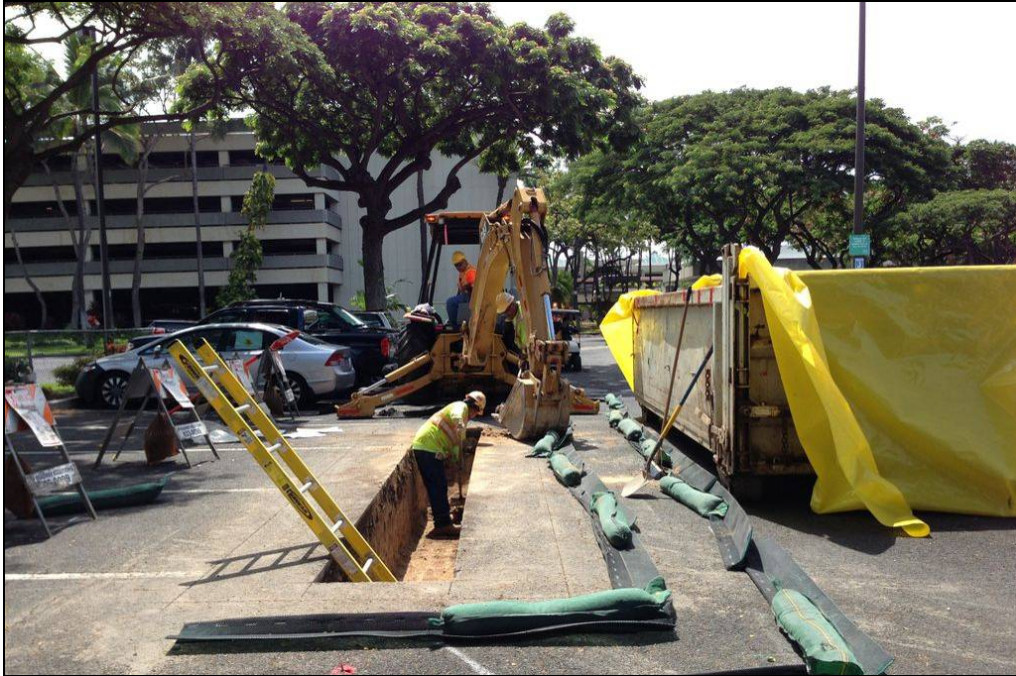
Figure 157. Photograph of Airport Section, T-026, general location, general view to south

Summary: The stratigraphy of T-026 consisted of fill (Stratum Ia to Id) overlying a buried concrete slab (Stratum II) at 82 cmbs. The stratigraphy of T-026 conforms to the USDA soil survey designation of Fill Land (FL). Excavation through and beneath the concrete slab was determined to be unsafe due to the potential for encased utility lines and sidewall instability. A 1943 map (Figure 19) indicates that during an expansive increase in military infrastructure development in 1942/1943, large buildings, understood as warehouses, were constructed in the immediate area of T-023 (with large buildings immediately to the east and west). A railroad spur line extended south from the OR&L rail line forming a loop in the immediate vicinity of T-026. This rail line suggests that large quantities of heavy material were stored in this immediate area. It seems likely that the buried concrete slab (Stratum II) within T-026 was a prepared, hard surface, possibly a receiving apron or dock, to facilitate the mass movement of supplies from the rail line to warehouses. The buried concrete slab, represented by Stratum II in T-026, has been designated as a component of SIHP# 50-80-13-7421 Feature 1 (see Section 7.4.3).

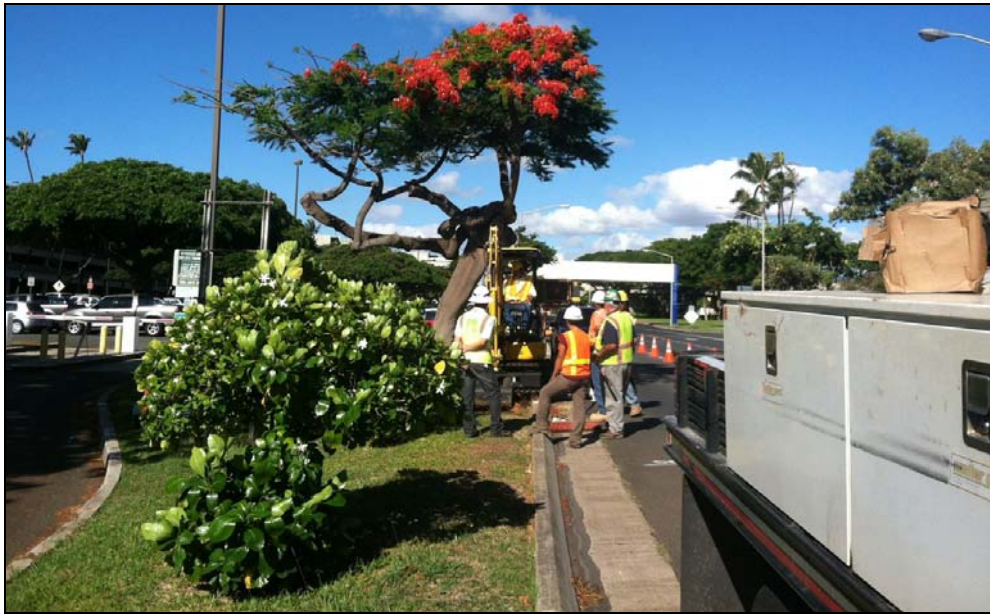
Figure 161. Photograph of Airport Section, T-027, general location, view to west

Setting: Test Excavation 27 (T-027) was located in the grassy area on the *makai* side of Ala Onaona Street (see Figure 160 and Figure 161). The excavation area is slightly elevated with a tree located to the west.

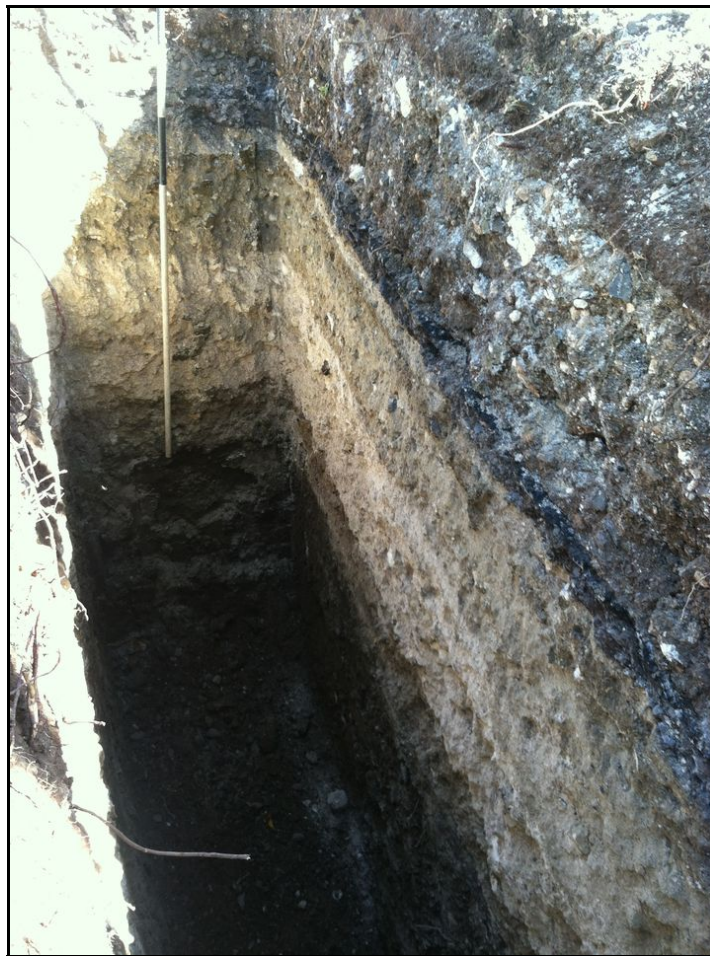
Figure 162. Photograph of Airport Section, T-027, general view of profile, view to southeast

Stratigraphic Summary: The stratigraphy, presented in Figure 162 and Figure 163, consisted of topsoil fill (Stratum Ia) and associated base course (Stratum Ib), a buried asphalt layer (Stratum IIa) and associated base course (Stratum IIb), crushed coral fill (Stratum IIc), and very gravelly sand fill (Stratum IId to IIe) overlying natural silty clay loam (Stratum III) to the coral shelf. The stratigraphy generally conforms to the USDA soil survey designation of Fill Land (FL) up to 179 cmbs, where natural alluvial sediment (Stratum III) was encountered.

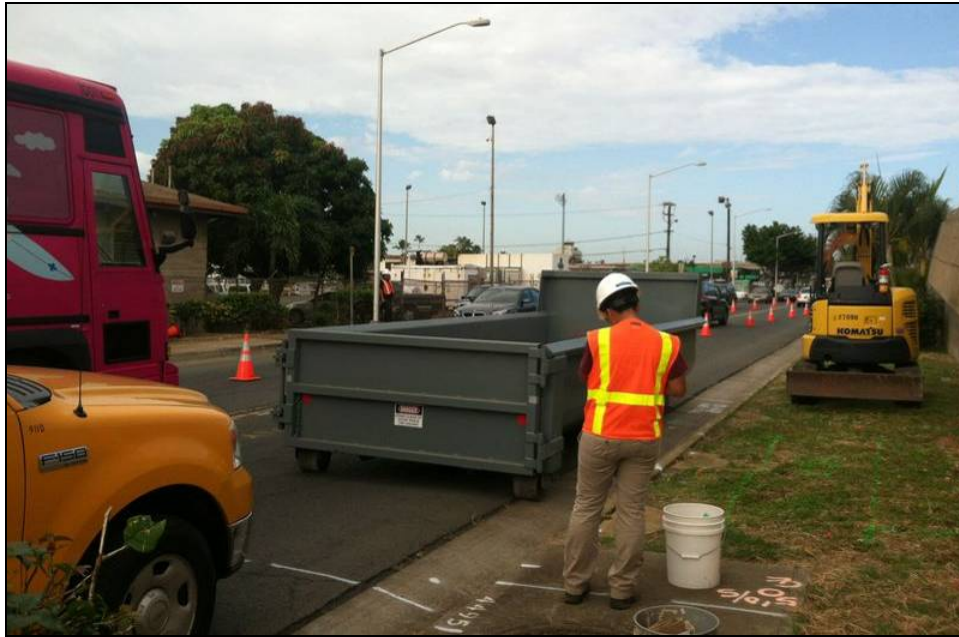
Figure 165. Photograph of Airport Section, T-028, general location, view to southwest

Setting: Test Excavation 28 (T-028) was located north (*mauka*) of Aolele Street and south (*makai*) of the H-1 on-ramp (see Figure 164 and Figure 165). The excavation area is slightly elevated in relation to the surrounding land surface.

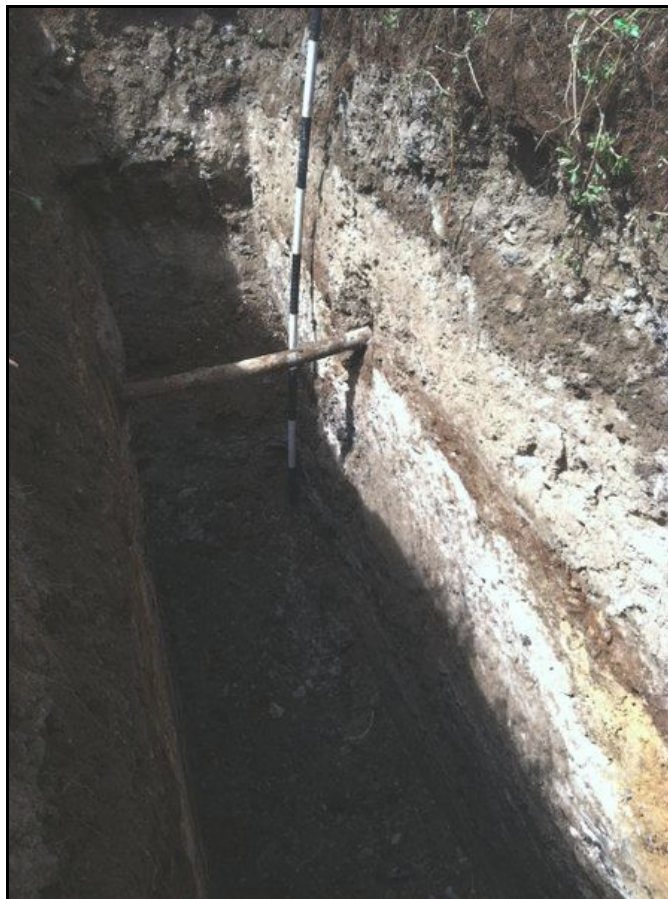
Figure 166. Photograph of Airport Section, T-028, general view of profile, view to southwest

Stratigraphic Summary: The stratigraphy, presented in Figure 166 and Figure 167, consisted of gravelly loam fill (Stratum Ia), very gravelly cobbly loam fill (Stratum Ib), very gravelly sandy loam fill (Stratum Ic), gravelly loam fill (Stratum Id) gravelly cobbly loam fill (Stratum Ie), and very gravelly sandy loam fill (Stratum If) overlying natural volcanic tuff bedrock (Stratum II). The stratigraphy conforms to the USDA soil survey designation of Fill Land (FL). All strata were consistent with fill sediment with the exception of volcanic tuff bedrock at the base of excavation (205 cmbs).

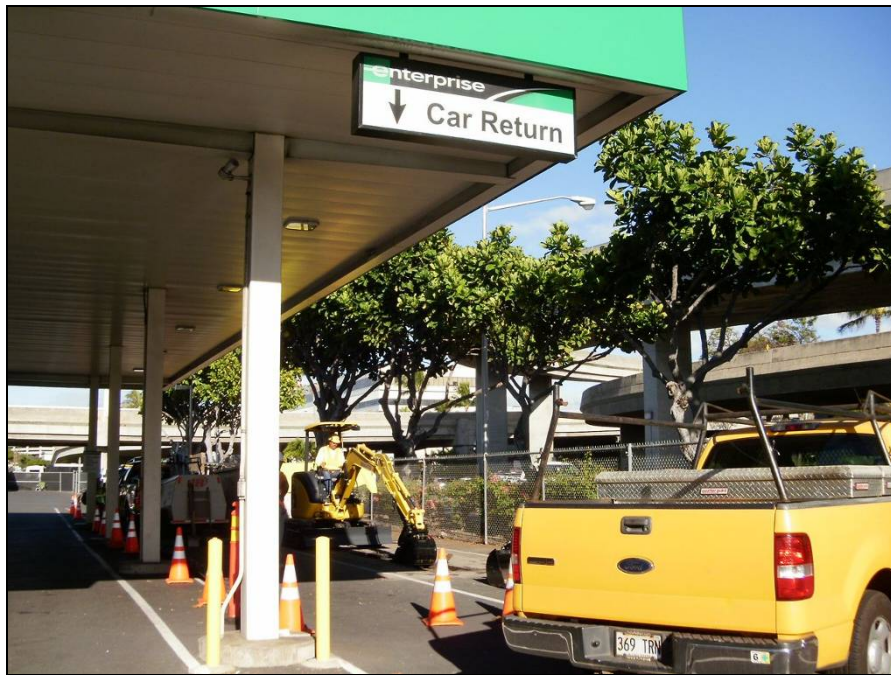
Figure 168. Photograph of Airport Section, T-029, general location. View to northwest

Setting: Test Excavation 29 (T-029) was located in the Enterprise Car Return area on the *makai*/'Ewa corner of Aolele Street and Aolewa Place (see Figure 164 and Figure 168). The excavation area is slightly elevated in relation to the surrounding land surface.

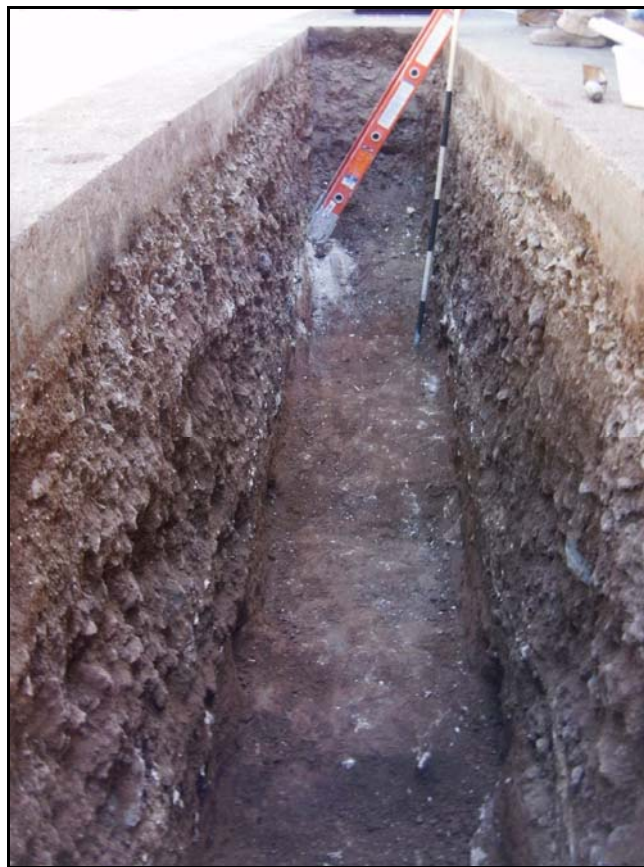
Figure 169. Photograph of Airport Section, T-029, general view of profile, view to west

Stratigraphic Summary: The stratigraphy, presented in Figure 169 and Figure 170, consisted of asphalt (Stratum Ia) and associated base course fill (Stratum Ib) overlying natural silty clay loam to the coral shelf. Stratum II appears to have been previously disturbed or reworked natural sediment. The stratigraphy generally conforms to the USDA soil survey designation of Fill Land (FL), with the exception of natural sediment (Stratum II) overlying the coral shelf.

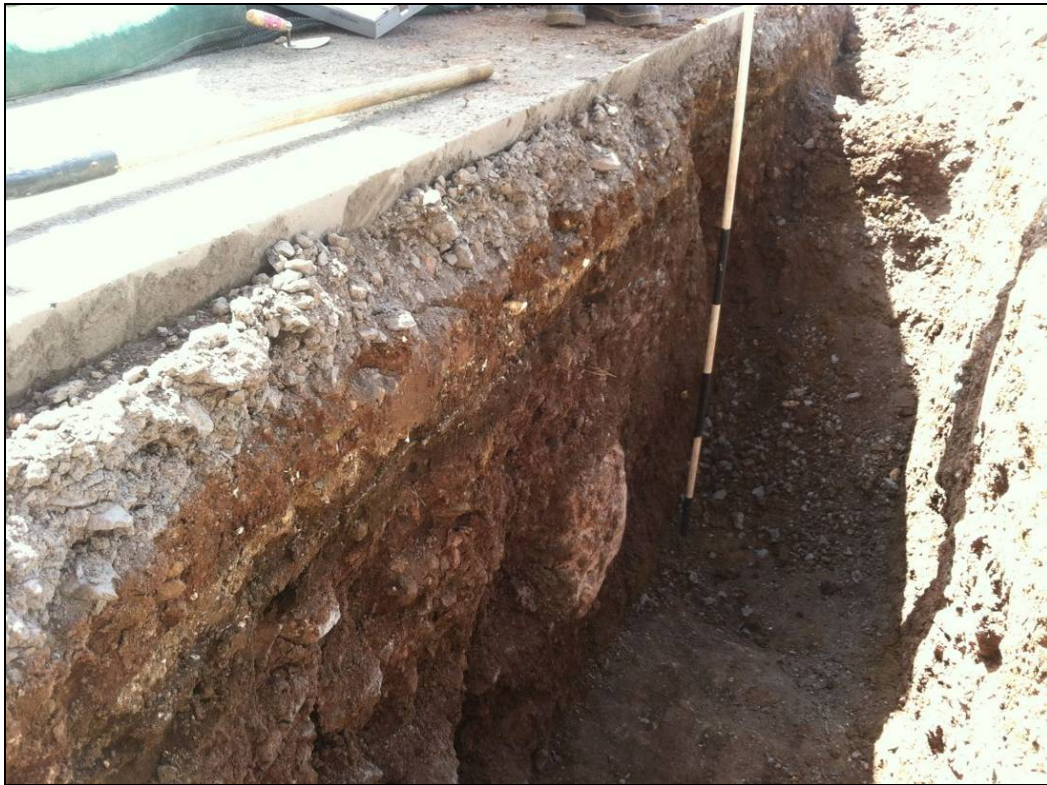
Figure 187. Photograph of Airport Section, T-033, general view of profile, view to WNW

Summary: The stratigraphy of T-033 consisted of numerous fill strata (Stratum Ia to Ie) overlying natural silty clay loam (Stratum II). Stratum II appeared to be consistent with the USDA soil survey designation of Ewa clay loam (EmA). A bulk sediment sample was collected from Stratum II, and a portion of the sediment sample was submitted for pollen analysis (see Section 8.3). The remainder of the bulk sediment sample was wet-screened yielding no significant finds within the sediment matrix. No cultural resources were identified within T-033.

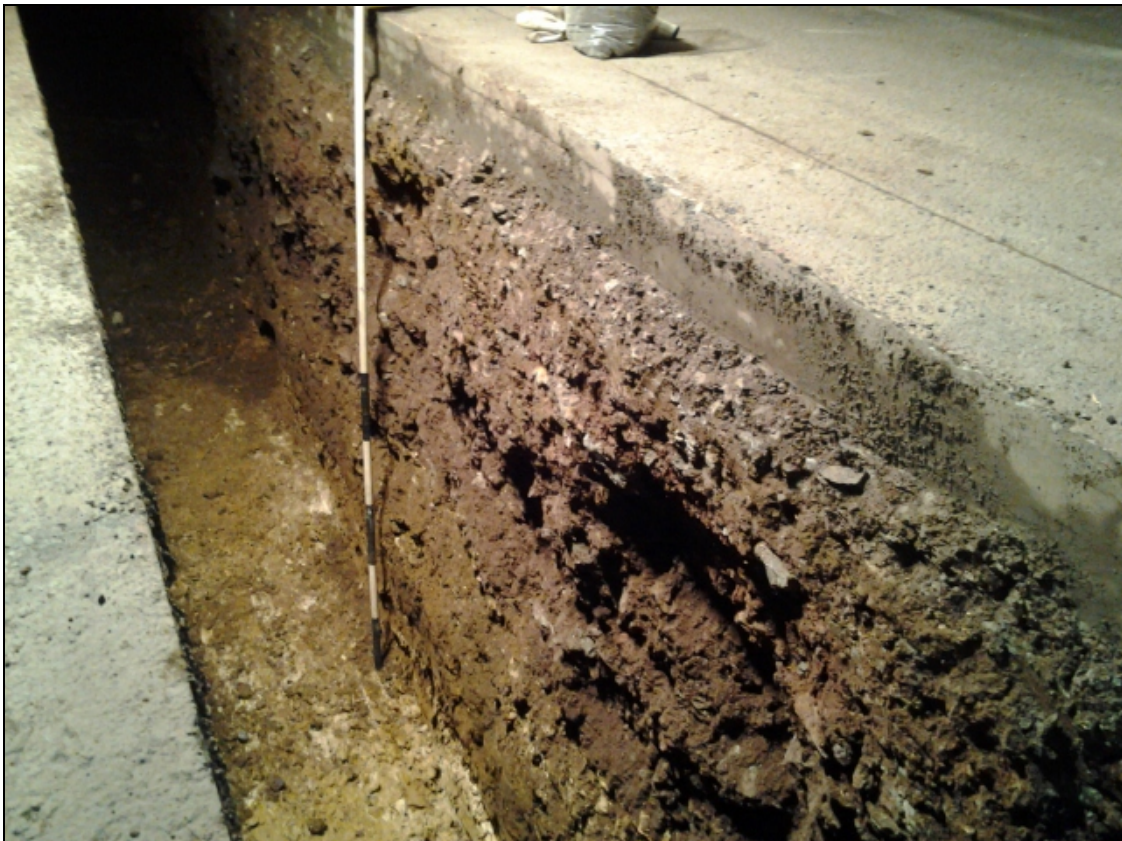
Figure 194. Photograph of Airport Section, T-035, general view of profile, view to southeast

Summary: The stratigraphy of T-035 consisted of fill (Stratum Ia to Ie) overlying naturally deposited silty clay (Stratum II) to the coral shelf (Stratum III). Stratum Ie consisted of a redeposited mixture of the underlying natural strata (Stratum II and III) and was therefore considered a locally-procured fill deposit. Stratum II appeared to be consistent with the USDA soil survey designation of Ewa silty clay loam (EmA). A bulk sediment sample was collected from Stratum II in order to further characterize the natural sediment. A trace amount of marine shell was identified during wet-screening. No cultural resources were identified.
